**REHABILITATION OF THE MANSOUR
PUMP STATION**

UNDER THE COMMANDER'S EMERGENCY RESPONSE PROGRAM

BAGHDAD, IRAQ

**SIGIR PA-07-111
JANUARY 24, 2008**

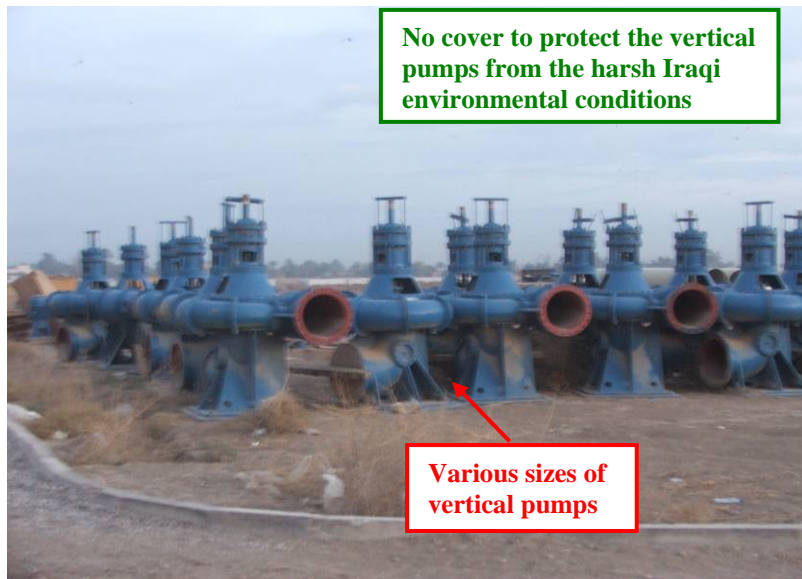
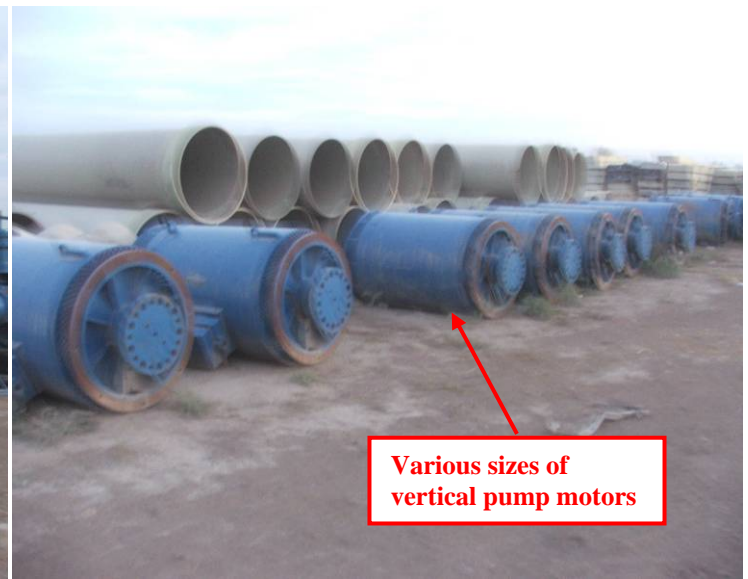
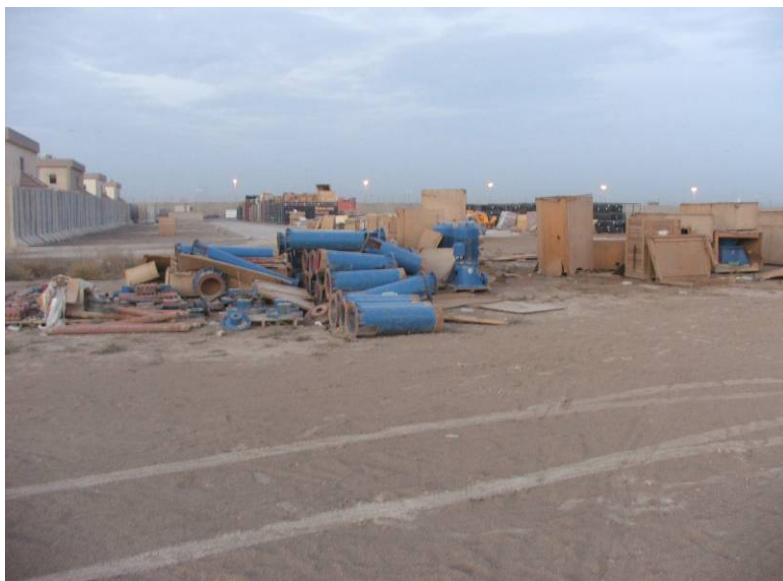
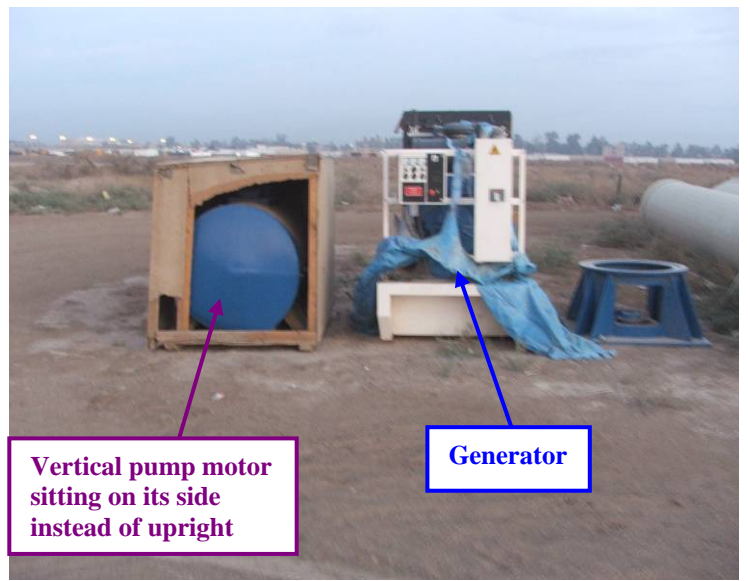
While not intended for the Mansour Pump Station, SIGIR is concerned that this critical equipment has been sitting idle at Gulf Region Central since 2005. Pump stations throughout Iraq are in need of vertical pumps and motors. In addition, SIGIR observed that the vertical pump motors were lying on their sides, which over time will result in degrading of the equipment (Site Photo 39). Several million dollars in equipment is neither being used for its intended purposes nor protected from the elements. For example, dirt, sand, and rain may make their way into the motor’s ball bearings, which could result in the failure of the motors. This equipment needs to be housed in a protective environment to eliminate the possibility of further damage. Because this equipment has been sitting outside in the elements for two years, the possibility exists that the equipment has been damaged. Therefore, a thorough inspection of each piece of equipment will be required to determine if the equipment is still functional.

Site Photos 36 and 37. Vertical pumps, motors, and accessories located behind the GRC HQs living quarters

Site Photos 38 and 39. Additional parts and accessories located behind the GRC HQs living quarters
